# Preliminary Assessment

## Simclar Inc., Dayton

### Former Simclar Facility

Dayton, Montgomery County, Ohio

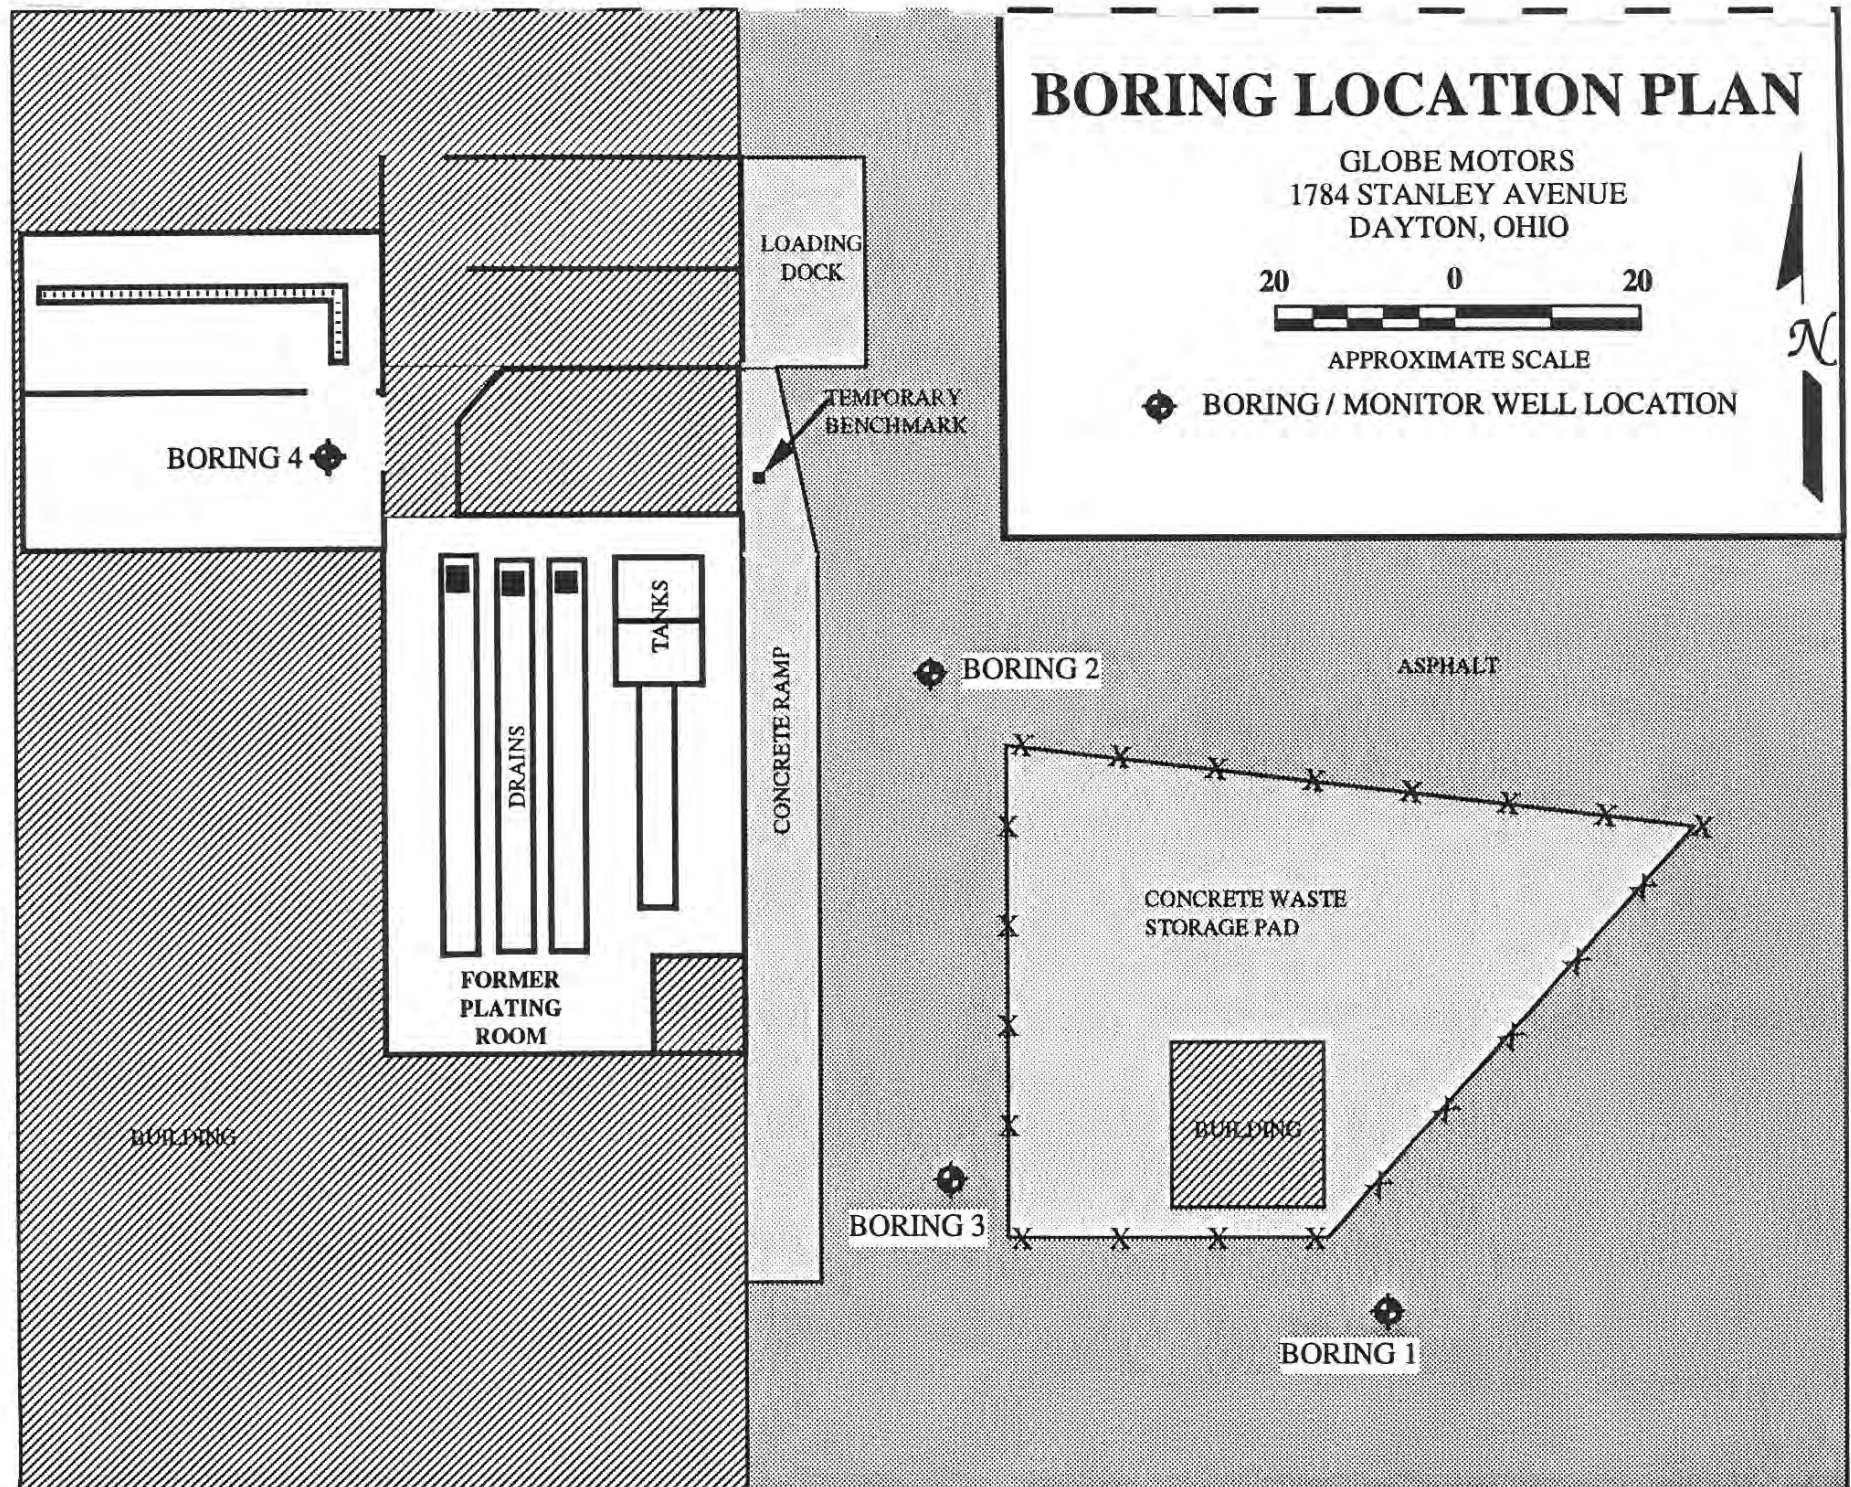
Figure 2: Phase II Investigation Sample Location Map (Bowser-Morner, 1994)

In 1994, a Phase II property assessment was conducted by Bowser-Morner and Environmental Assessment Services, Inc. to categorize waste being generated on site, to remove three above ground storage tanks (AST), and to investigate suspected releases of chemicals on site. Three monitoring wells and four soil borings were installed in an area that formerly stored bulk chemicals, drums of hazardous waste, solvents, plating chemicals, and three 1,000-gallon ASTs containing waste oil, waste coolants, and 1,1,1-TCA. **Figure 2** is from the 1994 assessment report and depicts where samples were located. Results indicated that cyanide and solvents had leaked through the floor of the storage area and that PCE, TCE, and toluene had been spilled north of the storage area. Ground water and soil sample results are provided in Table 1. The Phase II property assessment concluded that, though such chemicals were present above MCLs in the ground water on site, they posed no immediate health risk (Bowser-Morner, 1994).

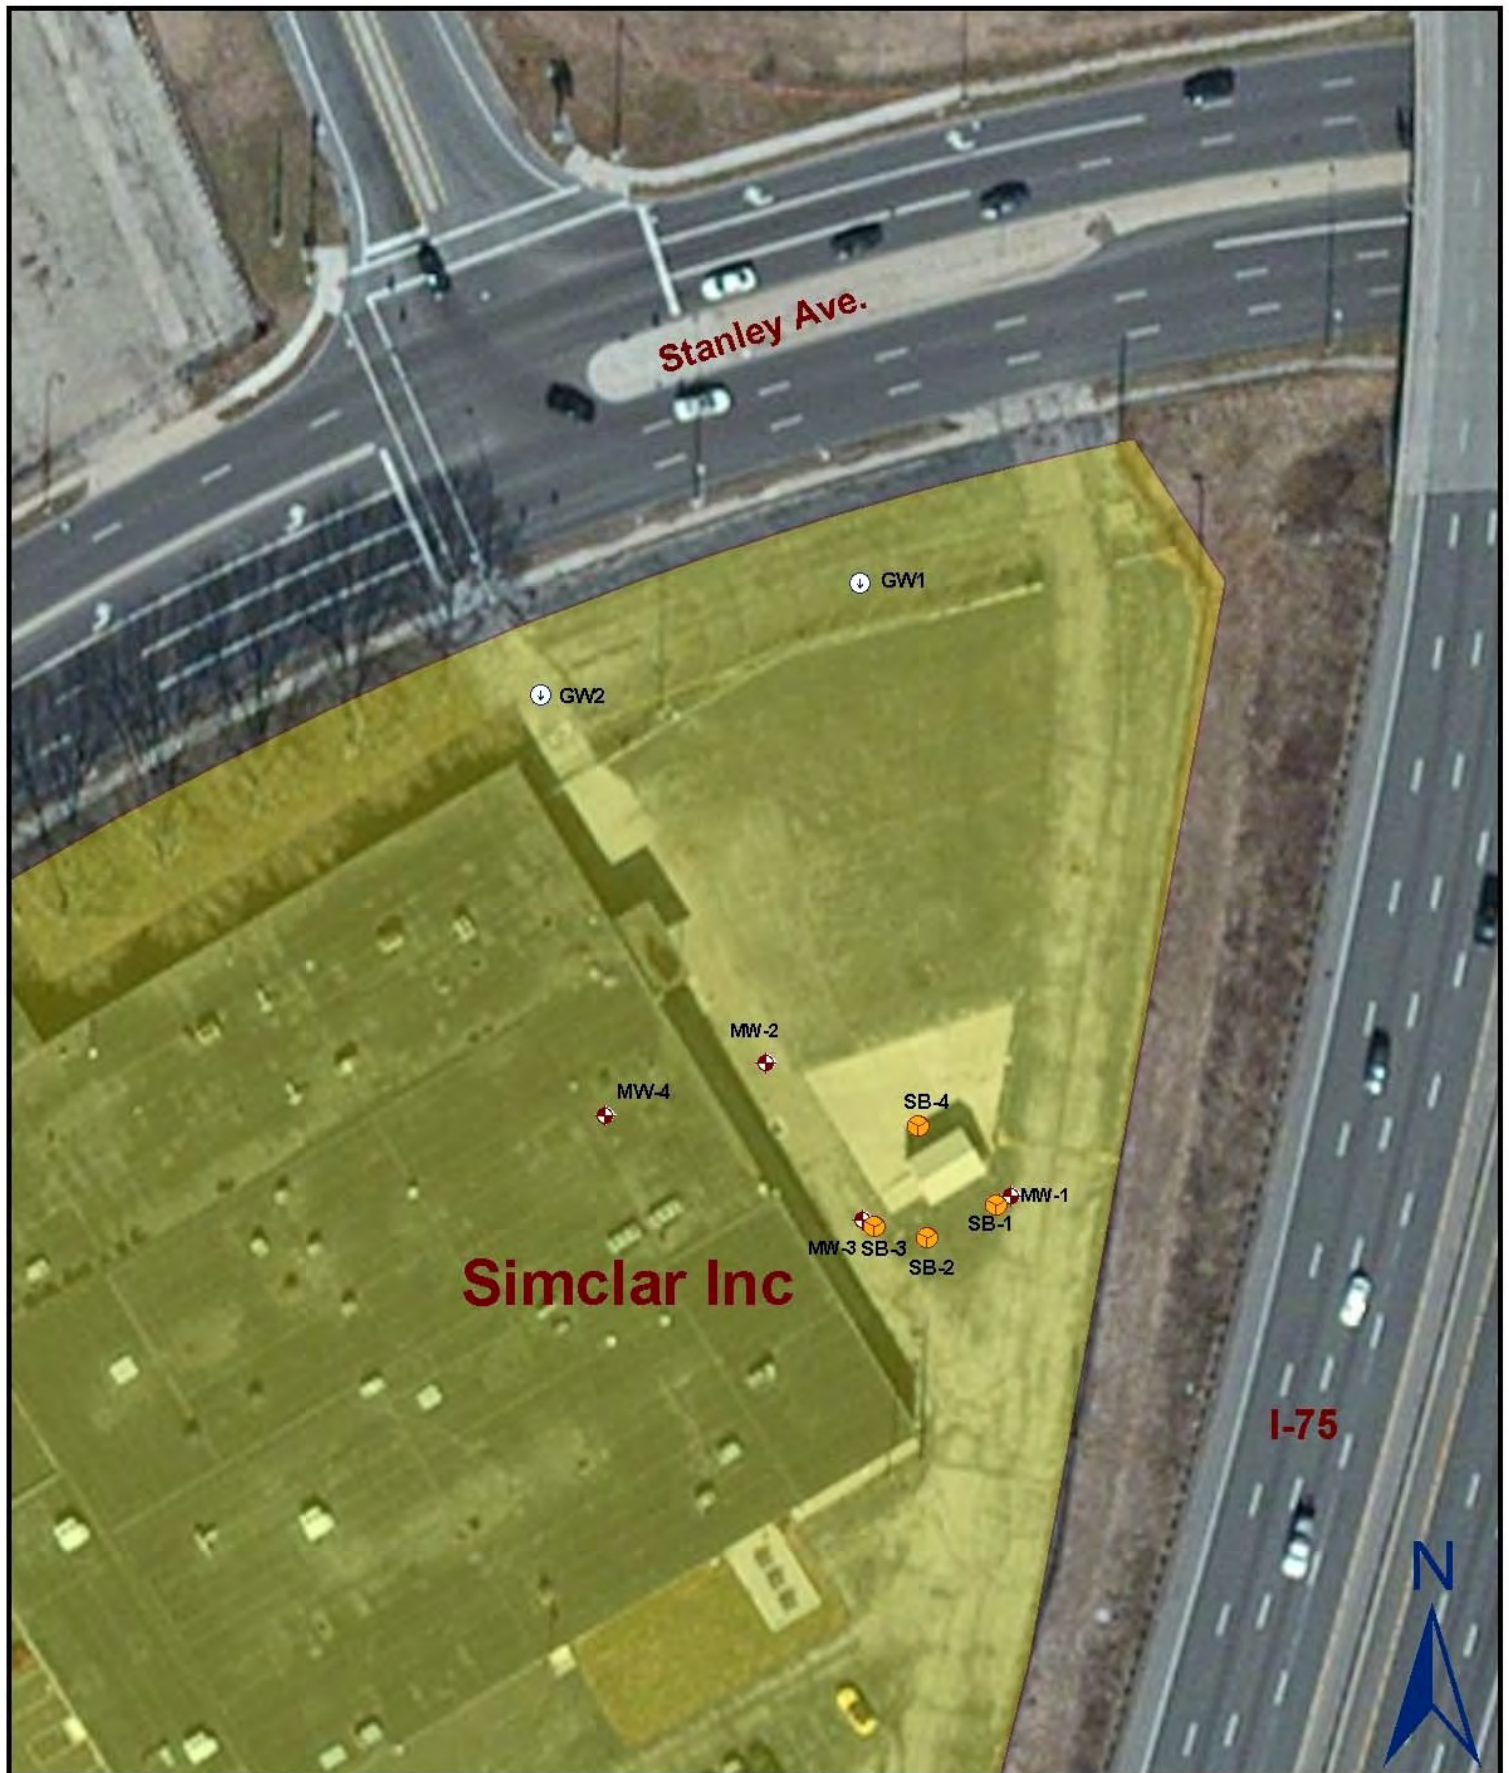
Figure 3: 2012 Phase II Expanded Site Assessment Sample Location Map

On December 3, 2012, a Phase II property assessment was conducted by Ohio EPA SIFU to mimic the 1994 Phase II property assessment by Bowser-Morner and to evaluate subsurface conditions. Soil samples targeted the bulk chemical storage shed. The goals of the SIFU Phase II included: verifying the release of VOCs to soil and ground water; locating contaminated soils that are acting as a source of VOCs to ground water; and determining the direction of ground water flow. **Figure 3** shows the location of samples collected by SIFU in 2012.
